LEVEL 1 REPLACEMENT RESERVE REPORT FY 2024 WINSTON MANOR

REPLACEMENT RESERVE REPORT

WINSTON MANOR

HUDSON, OHIO March 26, 2024

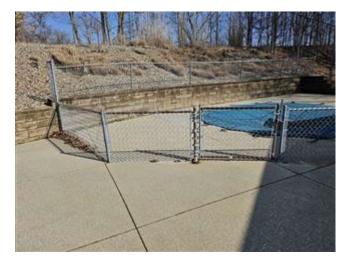
Fence posts can have an extended useful life if these simple maintenance activities are performed. If left unattended, the pressure from expansive post rust can crack and damage the supporting material.

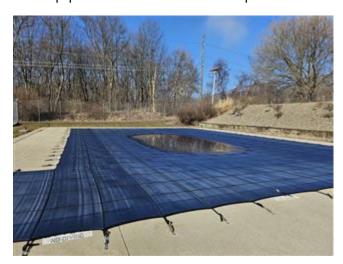
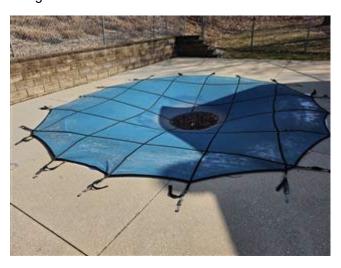
Pool equipment is contained within the pool house and appears to be in good condition.

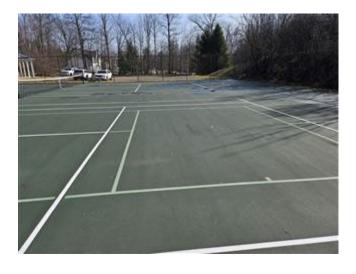
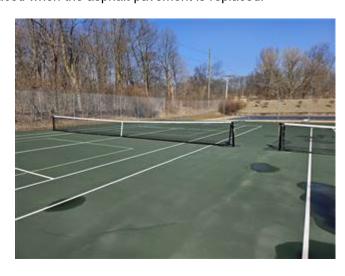
Tennis Courts. The community maintains two tennis courts. The overall condition of these courts appears to be in good condition with some chipping and cracking in the coating.

- Asphalt Pavement (base layer). We have assumed a service life of 20 to 30 years for the asphalt base layer.
- Color Coat (surface layer). Annual cleaning is recommended to maintain the surface of the court. The base of a
 tennis court is subject to cracking and low spots known as birdbaths that can occur from weather and earth
 movement. A program to address cracks as they appear will help prolong the color coat's useful life. We have
 assumed a service life of five to ten years for the color coat.
- Net Posts. We have assumed that the new posts will be replaced when the asphalt pavement is replaced.

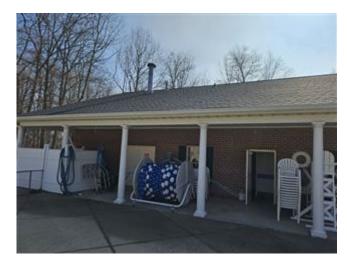
Building Roofing. The pool house building contains an asphalt shingle roof and the roof was reported to have been replaced in 2021 and is in good condition.

Asphalt shingle roofs can have a useful life of 20 to 50 years, depending on the weight and quality of the shingle. Weathered, curled, and missing shingles indicate they may be nearing the end of their useful life.

Annual inspections are recommended, with cleaning, repair, and vegetation mitigation performed as needed. Contractors and personnel should perform access, inspection, and repair work with the appropriate access equipment experienced in the roofing types used for the facility.

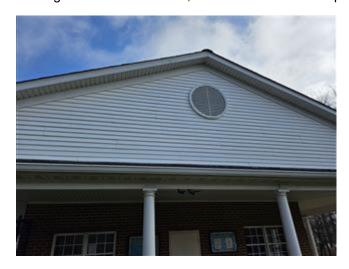
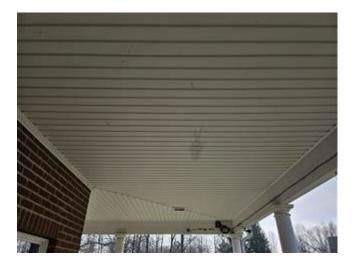
Siding and Trim. The pool house contains vinyl siding and vinyl ceiling. The vinyl appears to be in good condition.

Vinyl/Aluminum Siding and Trim can have an extended useful life if not damaged by impact, heat, or other physical reasons. However, the coatings and finishes typically have a useful life and, over time, begin to weather, chalk, and show their age. For these reasons, we have modeled for replacing the siding and trim every 25 years.
